Church's Hydronic System Receives Makeover After Years of Neglect

Comfort enhanced, energy use significantly reduced

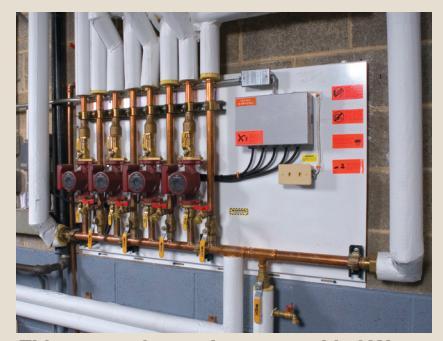
This pre-engineered, preassembled Watts Radiant Hydronex pump panel serves as the primary pumping station in the YCCoC facility. Each of the four multispeed Grundfos circulators handles a separate hydronic zone, each with its own flow and temperature requirements.

• Replacement of all system circulators. Three three-speed Super-Brutes and a larger VersaFlo from Grundfos were chosen to optimize system performance. With the flick of a switch, speed and, thus, head and flow can be changed to meet the needs of the system.

• Installation of a Watts Radiant Hydronex pump panel.

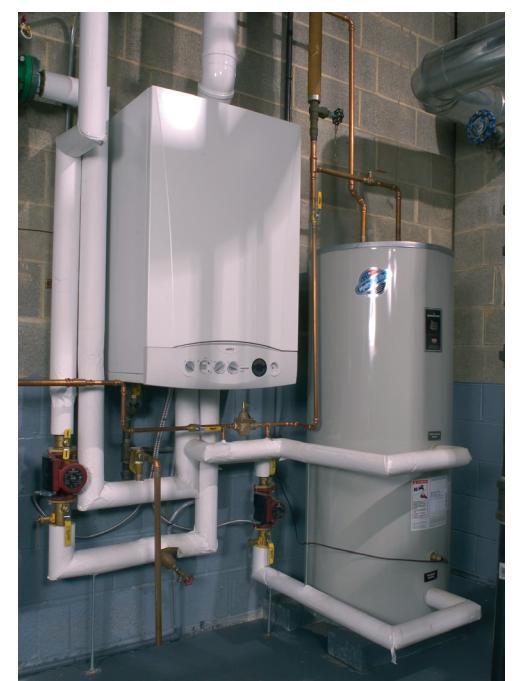
This 199-mbh Laars Mascot direct-vent modulating condensing boiler serves as the YCCoC's primary hydronic boiler and supplies heat to a 50-gal. Bradford White indirect water heater installed to handle all domestic-waterheating needs.

• Installation of a Laars Mascot high-efficiency modulating condensing boiler with outdoor reset. The lownitrogen-oxide, sealed-combustion, fully modulating boiler provides 96percent system efficiency at high fire. It comes with a built-in condensate trap and auto air-elimination vent. With aluminum outer piping and plastic inner piping, it can vent up to 33 ft— 45 ft for two-pipe installations.

a better choice for what's typically run as a high-temperature system," Yates said. "I'd have argued that same point a few years ago, but who says we have to run convectors at higher-thancondensing temperatures? The fact is, they work quite well when matched to outdoor-reset temperatures, and we use a modified reset curve so that the lowest temperature will be able to produce enough convection to offset the heat loss on milder days.

• Installation of a Bradford White indirect water heater.
