HVAC SOLUTIONS: Radiant warms 200-year-old New England church, improves IAQ

Radiant to the rescue

NEW ENGLAND CHURCH GETS THE MECHANICAL OVERHAUL OF A LIFETIME

Radiant retrofit solves an age-old indoor air quality problem at same time

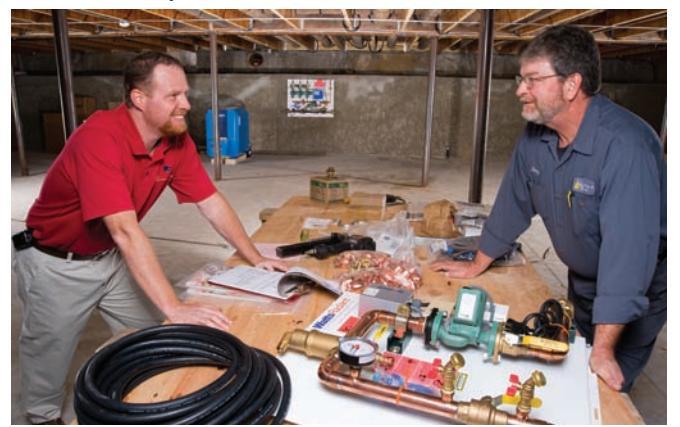
Jerry McKee, Huhtala service manager (L), and Darryl Delisle, Burner Service Professional, review materials and equipment needed for the job.

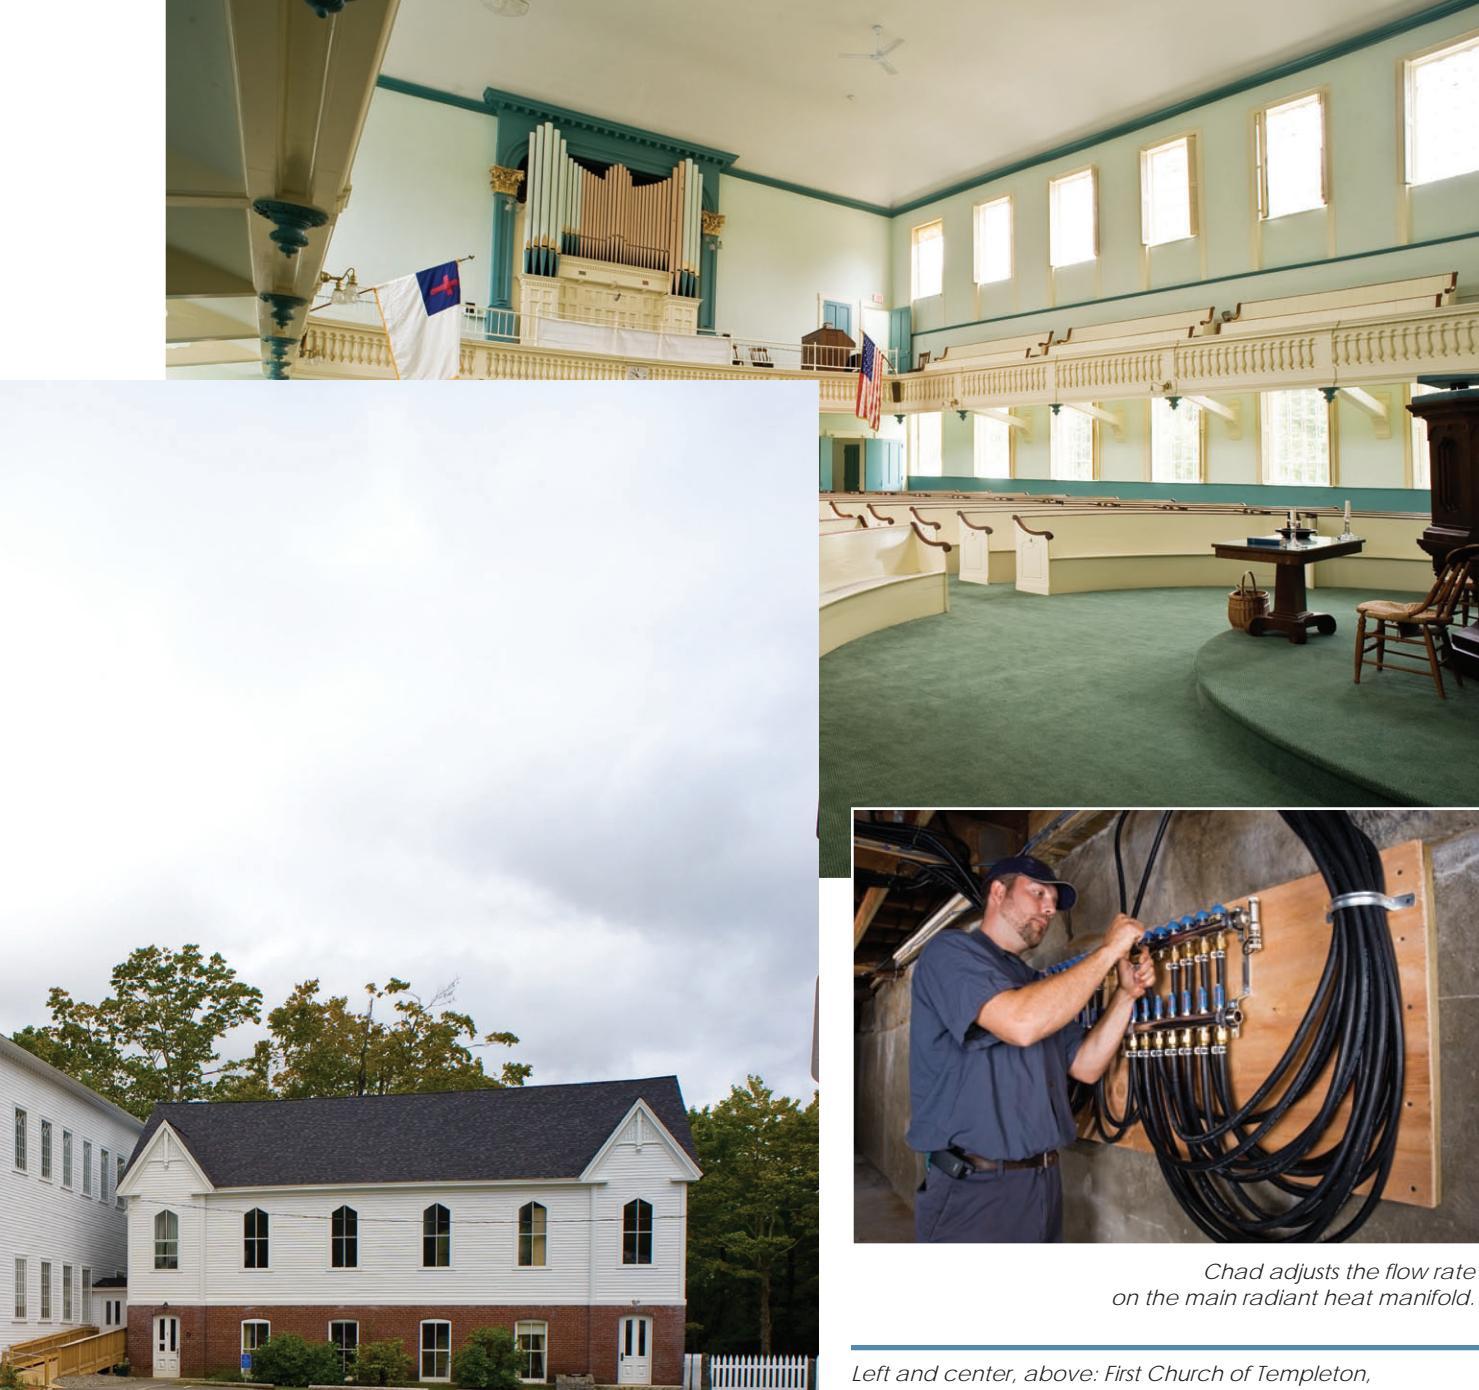
was built in 1811.

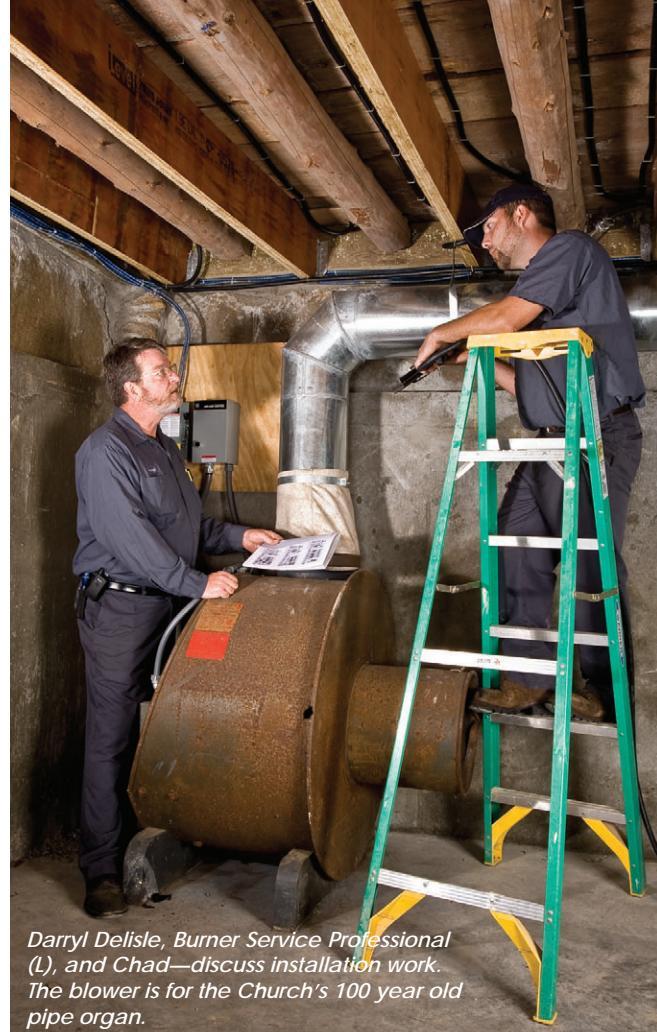
> So in went the Onix-7,800 lineal feet of it. Because of its flexibility, installers could connect both ends to a manifold, bend it back onto itself (with no fear of crimping) to push it through holes along the outer walls to assure equally-sized loops. The biggest advantage to Onix, however, is its ability to flatten slightly when stapled. This increases the heat transfer to hardwood flooring,

eliminating the need for expensive, time-consuming heat transfer plates.

Once they decided to deliver heat with staple-up radiant, Jerry McKee, Huhtala's service department manager, said they chose to use Onix (from Watts Radiant) over other tubing due to its versatility in staple-up radiant-Onix is pliable and flexible, and has virtually no memory,

> providing an ease of installation with the tight bends and random pipe spacing intervals that the old building brought with it.

"The Onix also worked perfectly because of our need to staple it in joist bays with plenty of obstacles and, occasionally, protruding nails that we could simply steer the tubing around," added McKee, explaining why he preferred it to less flexible tubing.
