I would like to share with you this article featured in <u>HPAC Engineering Magazine</u> about a 52-story high rise located in Los Angeles California. The article reflects solutions PumpMan provided the building's owner, Brookfield Properties.

Conserving Energy With a Pump System

High-rise office building's pressure-boosting system saves \$40,000

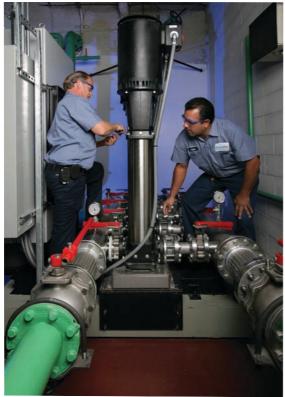
The new four-pump pressure-boosting system.

During Phase II, water service was shut down again for about 8 hr. During this time, PumpMan technicians turned off the high-zone pump system, disconnected all of the piping, and reconnected the domestic piping to the new four-pump pressure-boosting system.

Schedule 40, Type 316 stainless-steel pipe was used to replace the high-zone piping. Type L hard copper tube was used to supply the new system and the low zone. When the technicians tied the new high-zone piping into the existing building piping, the building was drained, the piping and electrical wiring were disconnected from the existing highzone pump system, and the main and emergency power were reconnected to the new system.

can power any of the system's four pumps. The pumps operate in a lead-lag arrangement, activating one pump that speeds up and slows down as water demand changes. Each of the four pumps is "rotated in" to act as the lead pump. Other pumps come online at full speed as demand dictates, while the lead pump continues to operate on the variable-speed drive to maintain a constant system discharge pressure. The pumps do not require pressure-reducing valves because the variable-speed drive ensures that discharge pressure does not fluctuate by more than a few percentage points, even with quick changes in demand.

Running only one pump on a variable-speed drive has reduced energy consumption and is expected to extend pump life and performance. Because of the new installations, the Figueroa's domestic-water pump system receives water from the city's supply at 50 psi and increases the pressure to 380 psi to push the water to the upper floors. An added benefit is that noise levels have been reduced.

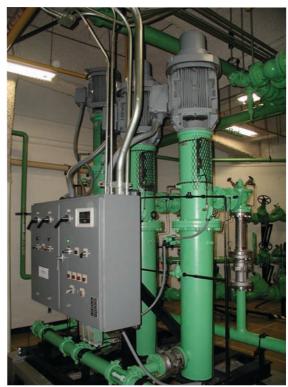
The high zone's original three-pump pressure-boosting system.

The building's 15-year-old constant-speed pump system consisted of two three-pump pressure-boosting systems—one for the low zone and one for the high zone. The low-zone system consisted of one 15-hp pump and two 30-hp pumps. The high-zone system consisted of one 30-hp pump and two 60-hp pumps. Because the old system was split into two zones, two pumps normally were running, even at periods of low demand. The motors ran at full speed and wasted large amounts of energy because there was no speed regulation.

All of the pumps had vertical turbines that used pressure-reducing valves to control discharge pressure. The valves were needed to taper the discharge pressure at each pump to avoid dangerous overpressurization. The old system discharged 500 psi at the building's lower floors while delivering 150 to 200 lb of water pressure to the upper floors. The system used the valves, as well as multiple regulators, every eight or nine floors.
